GASBUGGY

GASBUGGY POSTSHOT GEOLOGIC INVESTIGATIONS

November 1968

POSTSHOT GEOLOGIC INVESTIGATION—PROJECT GASBUGGY*

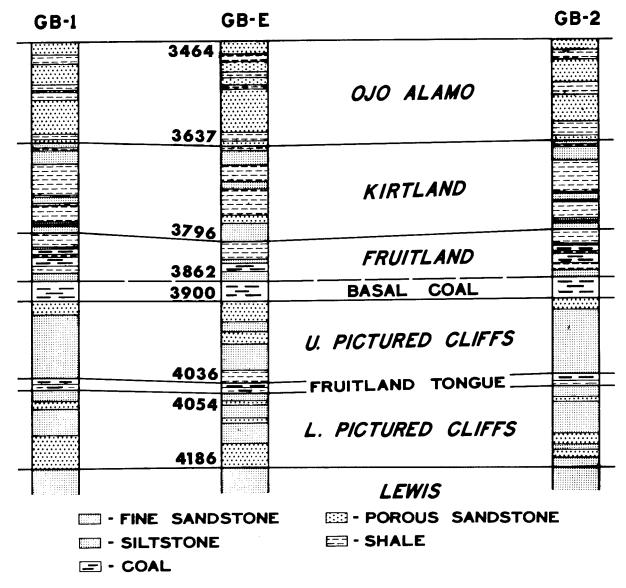
The stratigraphic panel in Fig. 1 illustrates the major rock units affected by the Gasbuggy explosion.

Fig. 1. Geologic section at Gasbuggy site.

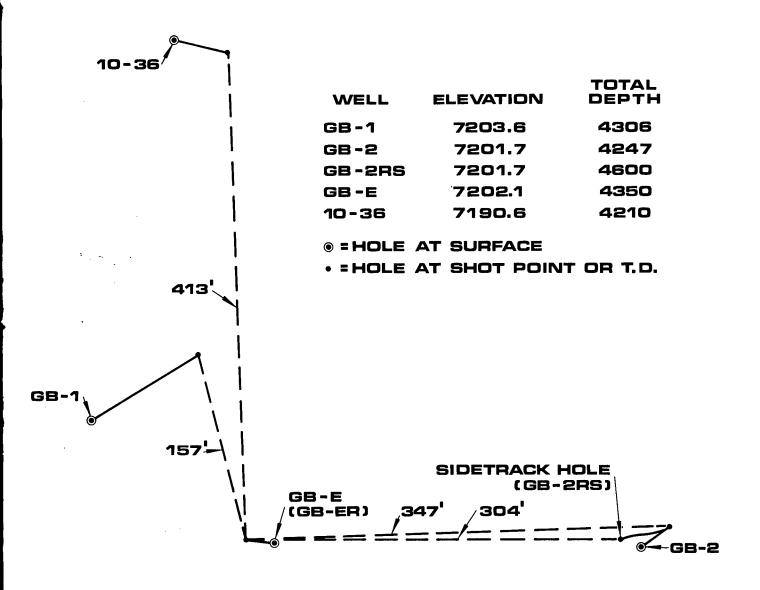
Figure 2 is a plan view of the pre- and post-shot hole locations, showing the surface locations of the holes and their locations in the vicinity of the shot point elevation. Care was taken in locating these holes to avoid possible major

Fig. 2. Plan view of tops and bottoms of holes at Gasbuggy site.

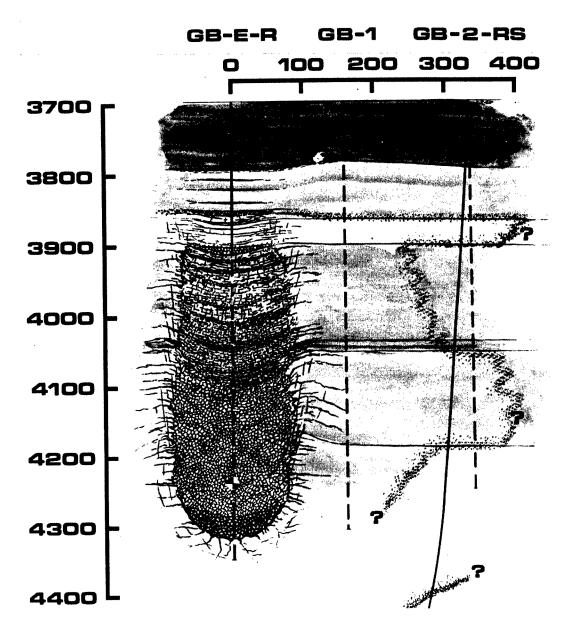
Figure 3 is a schematic cross section of the postshot Gasbuggy environment, as it is presently interpreted. The preshot holes are dashed, those drilled postshot are solid. Figures 4-6 illustrate the data on which this picture is based.

GB-ER encountered several casing breaks and two voids above the chimney top at 3916 ft. There was no large void at the top of the chimney and this region is interpreted as consisting of broken and sagged beds of rock. The chimney radius is drawn at 80 ft, the preshot prediction which is borne out by production data. ⁴

Fig. 3. Vertical cross section through Gasbuggy chimney and surrounding area, as determined from postshot explorations.

Returning to Fig. 3, it is apparent that the rock is fractured at least 650 to 700 ft from the explosion along pre-existing weaknesses in the rock. The indicated more general breakage of the Pictured Cliffs and Lewis shale is consistent with preshot predictions, as is the chimney height. Accurate quantitative determinations of change in permeability and gas production as a function of degree of fracturing are not possible at this time. There appears to be a significant effect on the geometry of fracturing due to the bedding of the rock and especially the low density coals. The general rock deformation results of the experiment, in the light of the limited data, are at least as encouraging to nuclear stimulation as preshot predictions had indicated.

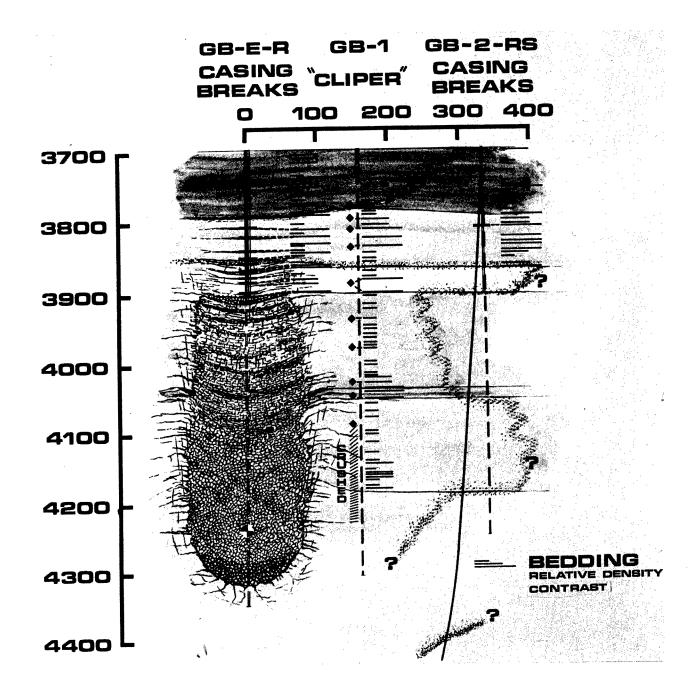
Fig. 4. Data from "Cliper" cables and casing breaks superimposed on cross section through Gasbuggy chimney.

Figure 4 shows the distribution of casing and cable breaks correlated with the preshot bedding in the rock. "Cliper" cables in hole GB-1 monitored the progress of the strong close-in shock. These brittle cables with a ceramic dielectric utilize a reflected high-frequency electrical pulse to continuously measure the electrical length of the cable. As the cable is crushed by the advancing shock, the indicated length decreases accordingly. Thus, the depth and time of cable breaks are determined. The data shows continuous crushing of the cable at a time coincident with the arrival of the shock wave. Above the crushed region, there are discrete breaks also developing at the time of arrival of shock.

The bedding planes are chosen at the contacts of the interbedded rocks of significantly different densities. The major bedding planes are where the density contrast of the adjacent rocks is the greatest. There is an apparent close correlation between both the casing and "Cliper" breaks with these bedding plane weaknesses. It can be presumed that weaknesses associated with jointing would respond similarly. (It should be noted that there are two concentric casings in GB-E, and a single smaller casing in GB-2.)

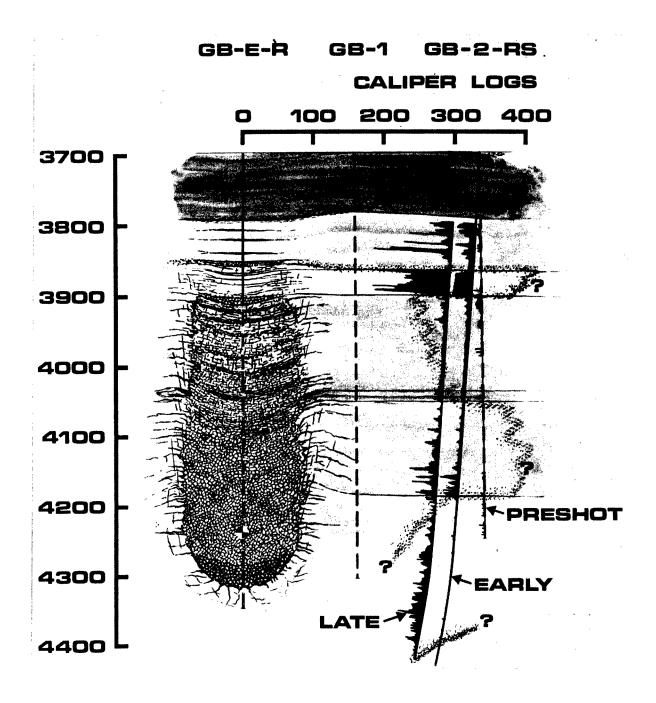
Fig. 5. Comparison of pre- and post-shot caliper logs, superimposed on cross section through Gasbuggy chimney.

The pre- and post-shot caliper logs shown in Fig. 5 give a gross indication of the failed condition of the rock encountered in GB-2RS. For these logs, the horizontal scale is greatly exaggerated. Note that the basal coal of the Fruitland was competent preshot and caving postshot. The early postshot log, run 10 hours after drilling stopped, indicated caving conditions in the lower Pictured Cliffs unit. The late log was run 35 hours after the hole was completed. Small amounts of water started seeping into the hole during the drilling of the sidetrack hole GB-2RS. This probably accelerated the caving of the rock, since the clay minerals are reactive with water. This later log shows pronounced caving of the Lewis to a depth of 4400 ft, and less caving to the total depth of 4600 ft. This is suggestive

of shot-induced fracturing which would allow greater penetration of water into the shale, which in turn accelerates caving.

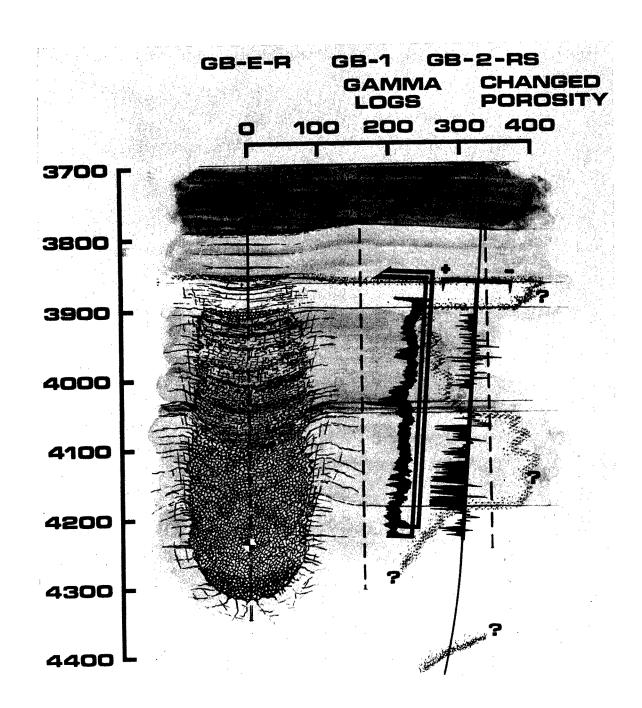
Fig. 6. Changes in porosity and comparison of pre- and post-shot gamma logs, superimposed on cross section through Gasbuggy chimney.

The relative changed porosity of the Pictured Cliffs formation (Fig. 6) shows a pattern similar to the caliper log—the lower unit has increased porosity significantly more than the upper unit. The pre- and post-shot gamma-ray logs indicate that the general rock character is the same in holes GB-2 and GB-2RS. That is, there are no pronounced lateral facies changes. The plot of changed porosity was constructed from the calculated porosity of the pre- and post-shot "sidewall-compensated density logs." Errors in this technique introduced porosity exaggerations, so the absolute values are accordingly somewhat in doubt, but the relative changes are considered valid. If one assumes no compaction of rock at this distance, the decreased porosity shown on the right gives an indication of the statistical uncertainty of this approach.

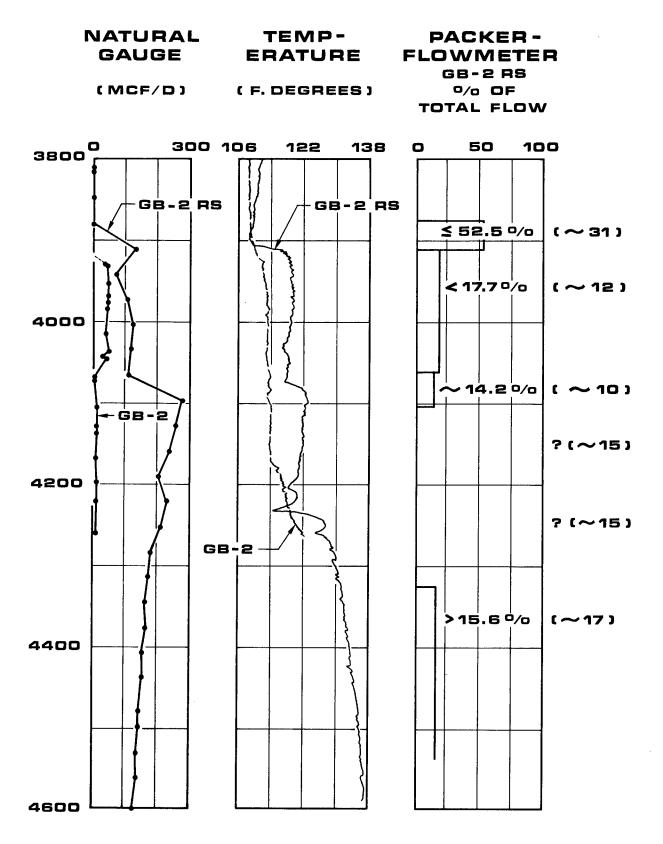
Figure 7 illustrates the effects of the explosion on the gas production characteristics in hole GB-2RS. On the left are the pre- and post-shot natural gauge data. This illustrates more general gas entry postshot than preshot.

Fig. 7. Comparison of pre- and post-shot gas production data in drill holes GB-2 and GB-2RS.

The production data in this hole should be considered minimal because there is thought to be a high probability of skin damage. As the hole was being drilled, there was believed to be a slight water leak entering the hole at a depth of approximately 3812 ft. Also, the drilling gas consisted of about 8% propane and butane fractions. Continued water entry and caving of the hole prevented continued use of this hole for gas production testing. Only enough gas was produced to allow migration of a small amount of radioactive gas from the chimney to this hole. The indicated temperature increase postshot, shown

in Fig. 7, would suggest communication with the hotter chimney region, as would the observed increase in the ${\rm CO}_2$ content of the gas after limited flow.
